# Manhole Inspection Summary

Manhole # S31EE\_037MH

Insp Date: **1/24/07 10:45 AM**

**Location** Address: **PARK AVE**

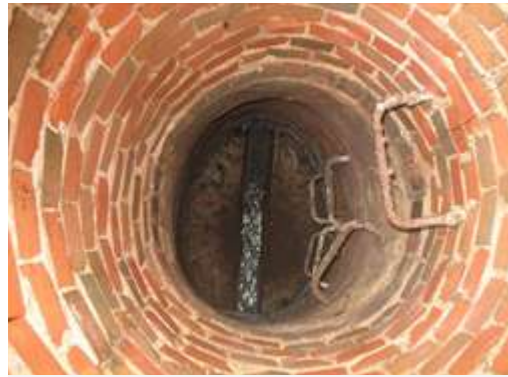
Top View

Adjustment and Barrel infiltration.  
Corroded steps. Evidence of surcharge -  
Bench debris.

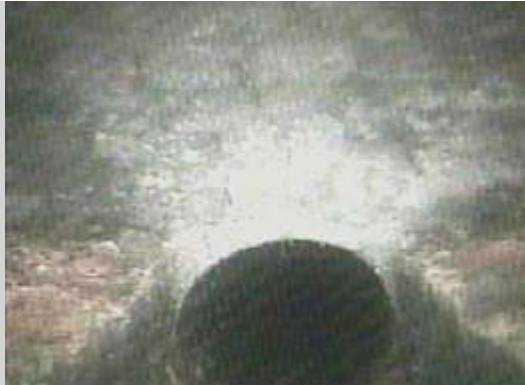
### 8 in. Circular Gravity Sewer Pipe Out @ 12 O'Clock

Invert Depth: **12.74** (ft.) Flow Characteristics: **Fast**

Infiltration: **None** Pipe Seal Cond: **Unknown**

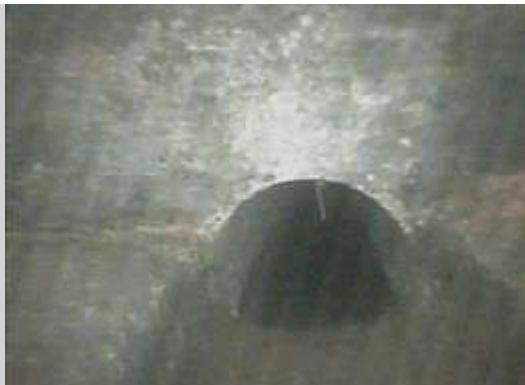
### 8 in. Circular Gravity Sewer Pipe In @ 6 O'Clock

Invert Depth: **12.60** (ft.) Flow Characteristics: **Fast**

Infiltration: **None** Pipe Seal Cond: **Unknown**
